Monitoring Cruise at the Massachusetts Bay
Disposal Site, August 1990

Disposal Area Monitoring System DAMOS

Contribution 92
November 1994

Report No.
SAIC-90/7599&C90

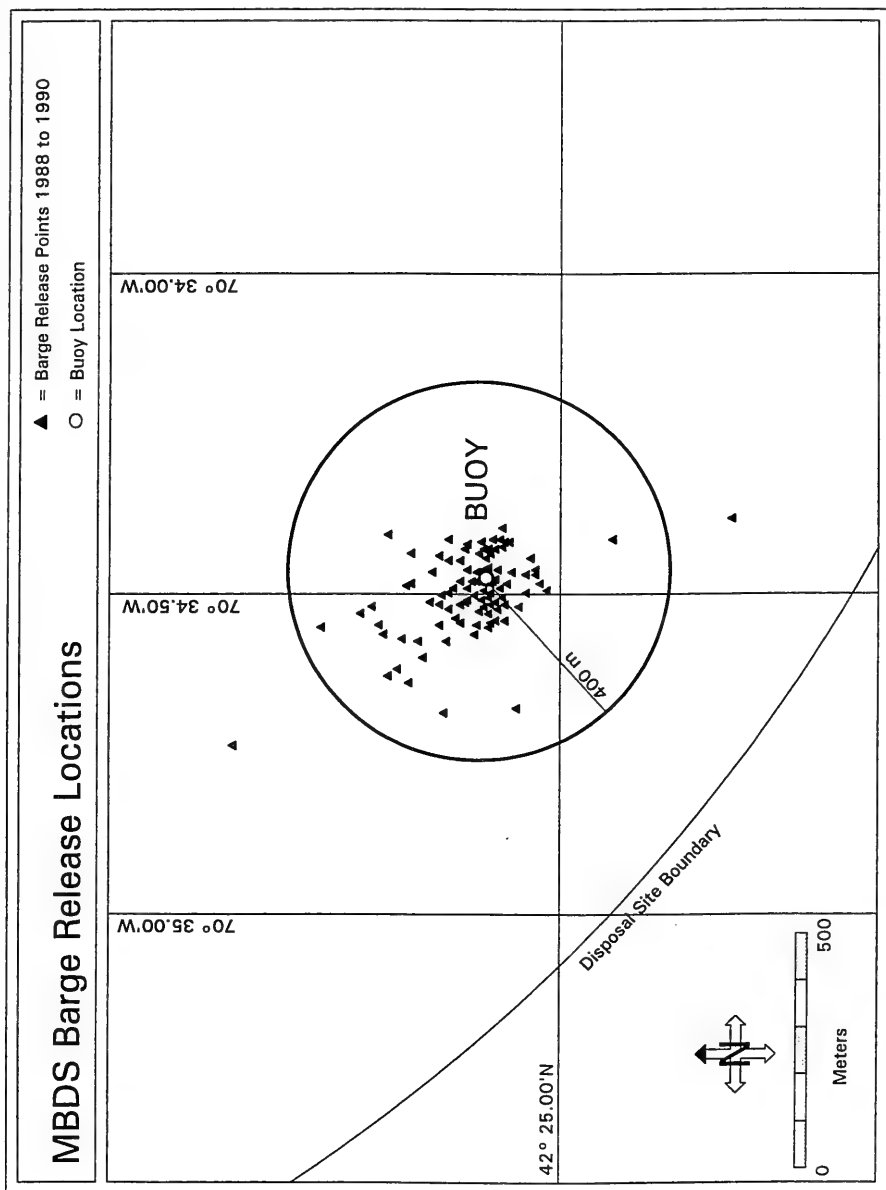
Figure 4-1. A plot of the barge release points for 1988-1990. The plot indicates that the majority of barges released dredged sediments within 400 m of the buoy location.

The presence of dredged material in a large number of REMOTS® stations away from the disposal buoy is primarily related to vessel positioning at the time of disposal. The expected radius of an individual disposal event (2,000 m³ at a 90 m depth) as calculated by the DAMOS capping model for MBDS indicates that material would spread a distance of 300 meters (Figure 4-2) from the point of impact. A plot of the barge release points (Figure 4-1)

indicates that this would account for material deposited to the north, south, and east of the buoy. Barge release points do not, however, account for the dredged material deposited out to 800 m west.
